Selection of a Non-ODC Solvent for Rubber Processing Equipment Cleaning

R. E. Morgan and T. N. Thornton
ATK Thiokol Propulsion

Abstract

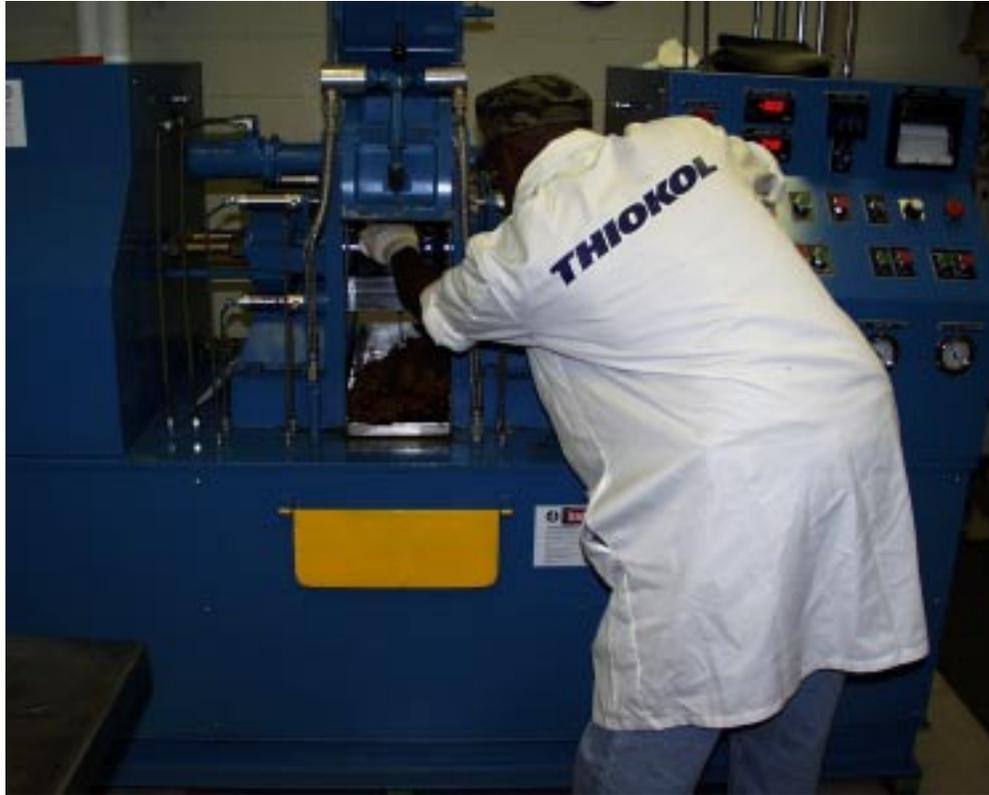
Figure 1 NASA MSFC Rubber Mixer

Figure 1 shows the small-scale rubber mixer that has recently been installed at MSFC for the purpose of making and testing small batches of rubber. The mixer is a 6 lb capacity Banbury style mixer that is similar to the full size production capacity mixers. These mixers use tremendous power to literally chew, or masticate, rubber and solid fillers into an acceptable mixture. The mixture is pulled from the mixer and then flattened, or calendered, into a thin sheet with a calender roll mill. Figure 2 shows the calender mill that was recently installed.

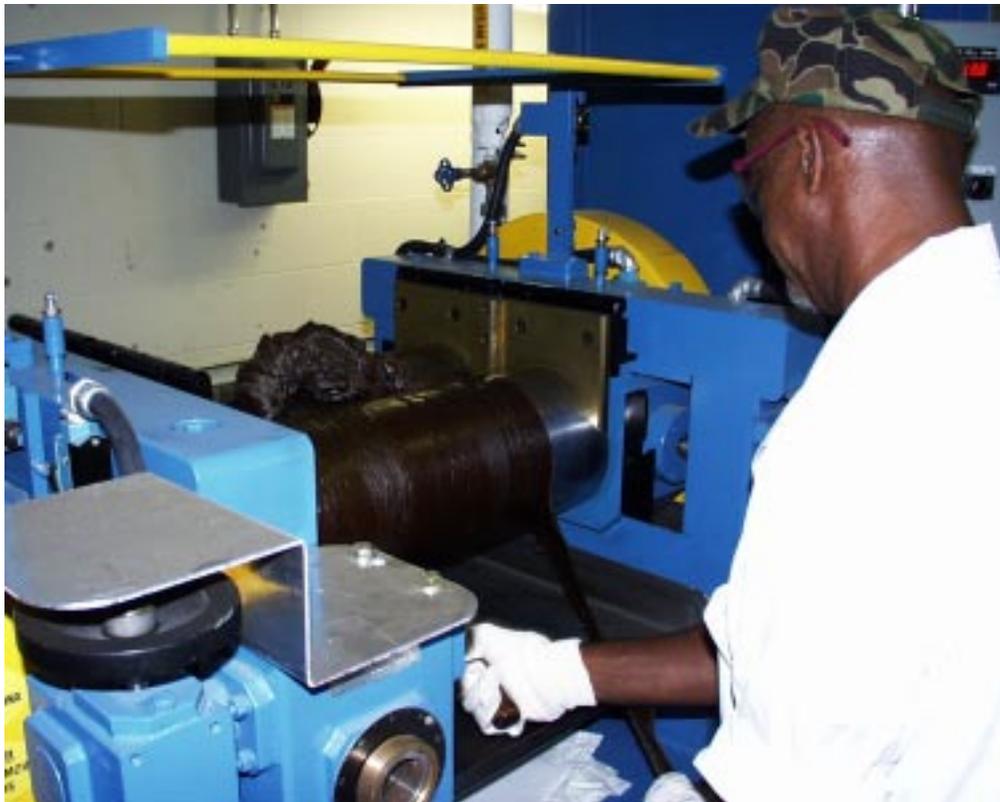
Figure 2 NASA MSFC Rubber Calender Mill

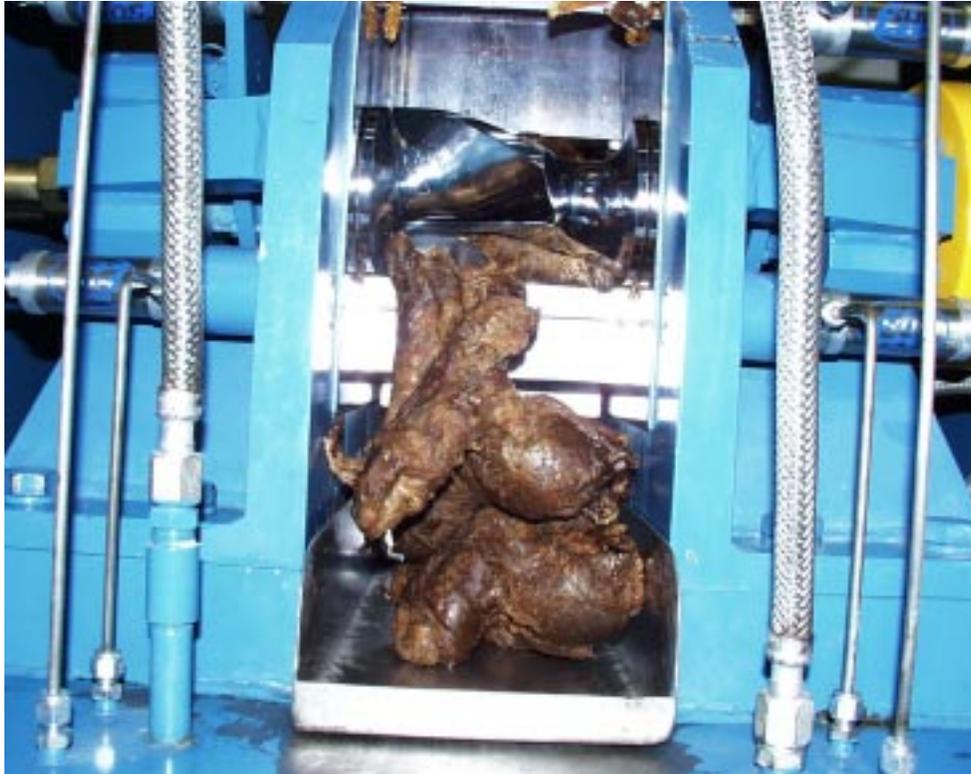
Figure 3 Rubber Mixer Cleaning with Natural Rubber

Natural rubber is used to clean the mixer and mill by removing gross contamination from the mixer or mill surfaces as shown in Figures 3 and 4. There still remains a film of rubber and traces of raw materials that need to be removed from the mixer or mill. This has usually required the use of solvents.

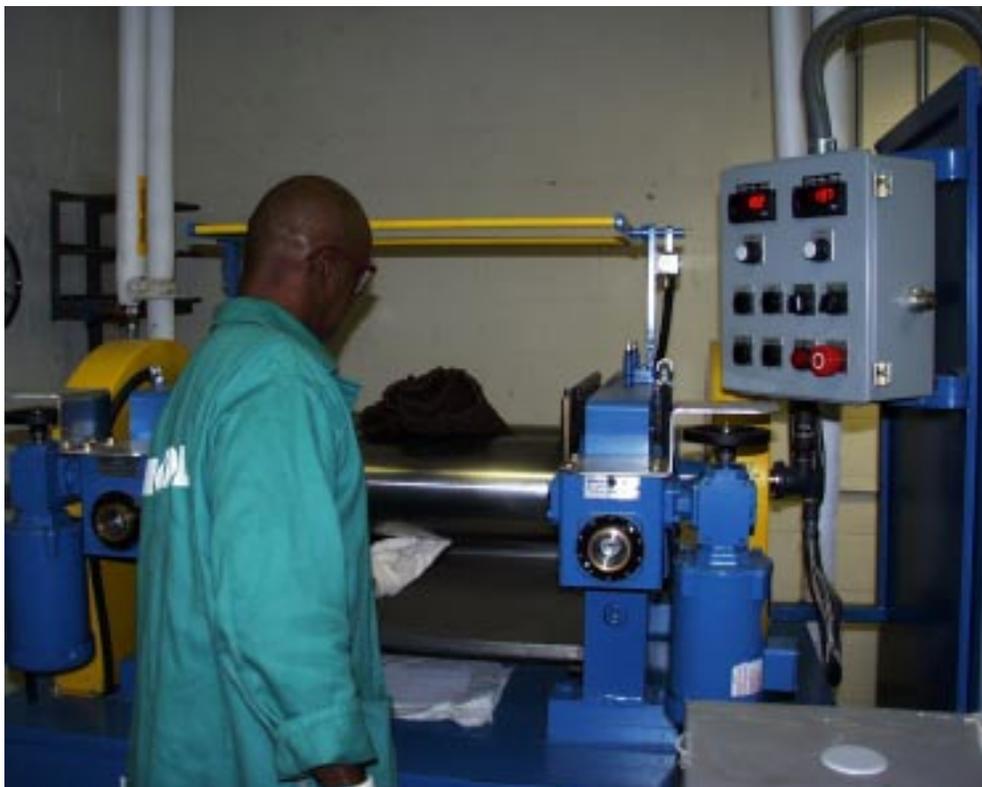
Figure 4 Rubber Mill Cleaning with Natural Rubber
